STUDY OF REPAIR AND RENOVATION OPTIONS

405 River Street
Alpena, MI 49707

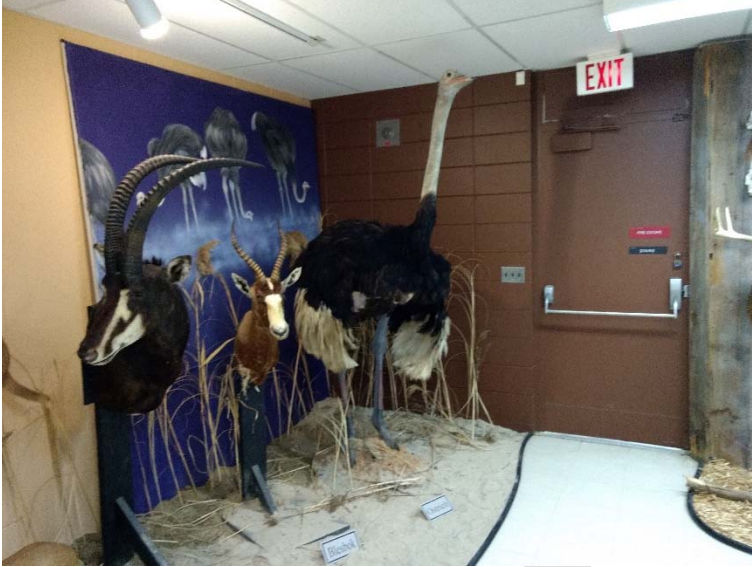
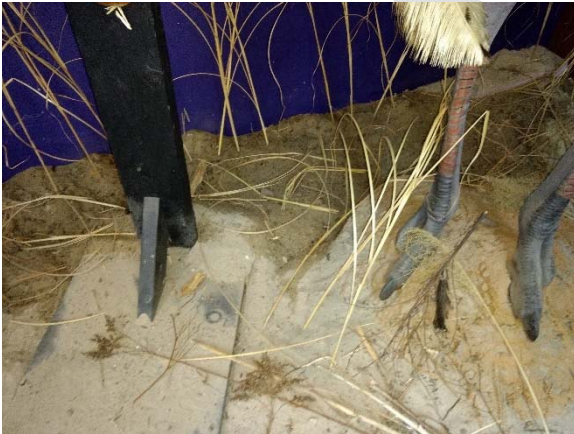
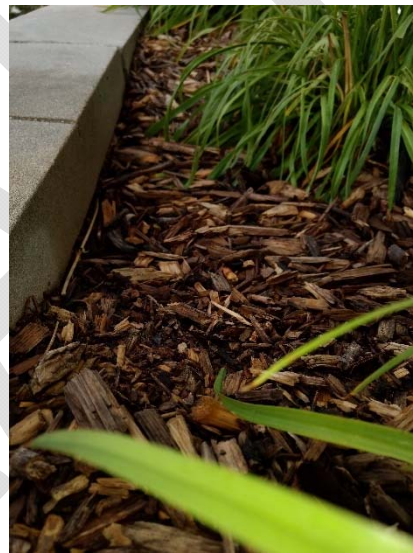
- The Lower Level drawings are being reviewed by Architect for code compliance and egress
- The current space usage is not optimal and in coordination with the Museum Director, alternate usages of the lower level space have been reviewed both for improved space use and better preservation of the collections
- Current lower level does not have adequate temperature controls and humidity controls. Options will be looked at to improve the environmental controls for the collections.
- The space currently housing the animals exhibit has had 2 noticeable instruction of water. One episode seemed to have come from the exterior and entered above the ceiling. Possible cause is water coming from the planters. This will be addressed with

removal and/or rebuilding of the planters.

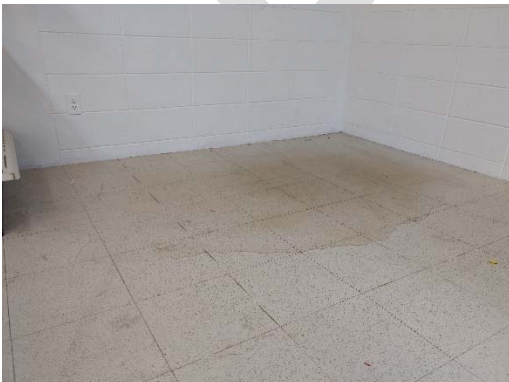
- The second episode seemed to indicate water coming up through the floor. It is suspected that this may be a result of a broken or cracked drain tile that runs under the floor from the drain at the base of the exterior stair

WATER ON FLOOR BUT WALL IS DRY

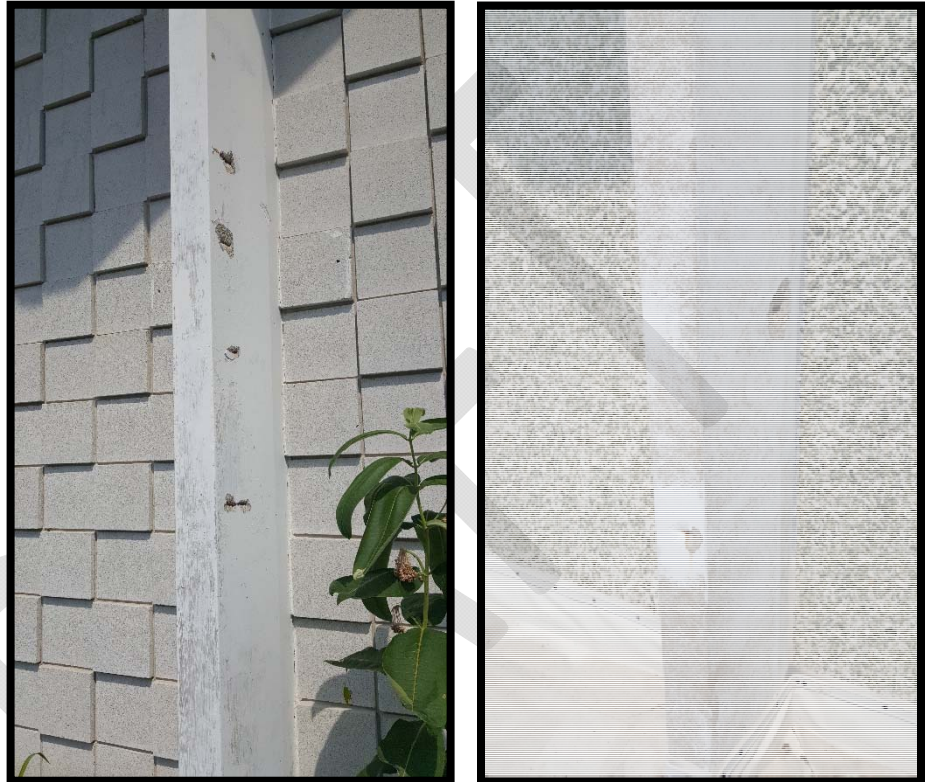
Figure 1 : columns spalled concrete exposing re-bar

Many of the exterior columns are showing signs of deterioration marked by spalling and popping of the concrete, exposing re-rod. This needs to be corrected to prevent water from continuing to penetrate the column and rust out the re-rod which would eventually lead to failure.

To correct this, the areas around the deterioration need to be saw-cut. The re-rod needs to be cleaned and then a protective anti-corrosion coating such as and then patched. The concrete covering the rebar needs to be chipped away to expose as much of the corroded surface as possible, loose rust should be brushed off, and a coating applied. Chip away all loose material, exposing clean, sound concrete

Clean the re-bar and coat with an anti-corrosion compound. The surface should be rough when the chipping process is finished. Next, mix a repair batch of Portland type 2 cement with fine, sharp masonry sand in a one to two ratio. Add latex bonding additive to bring the repair material to a stiff, plastic consistency. Dampen the exposed concrete of the column with water, a whitewash brush works well for this, then use a rubber float to pack the patch material into the spalled area. Pack the material tightly so that there are no voids in it, shaping it with the rubber float to a smooth surface matching the column's shape. Allow it to begin to set (harden), at normal temps and humidity, about 2 hours. After the patch has taken its initial set, dampen your rubber float and "rub" the patch in light, circular motions until the patch matches the texture of the rest of the column

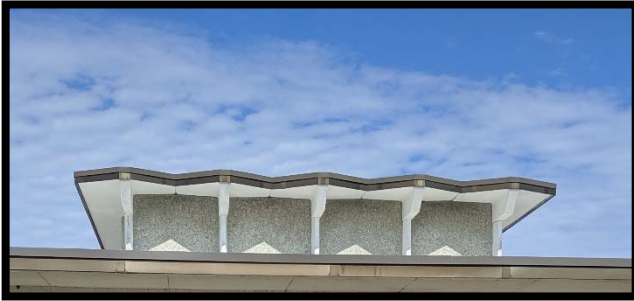
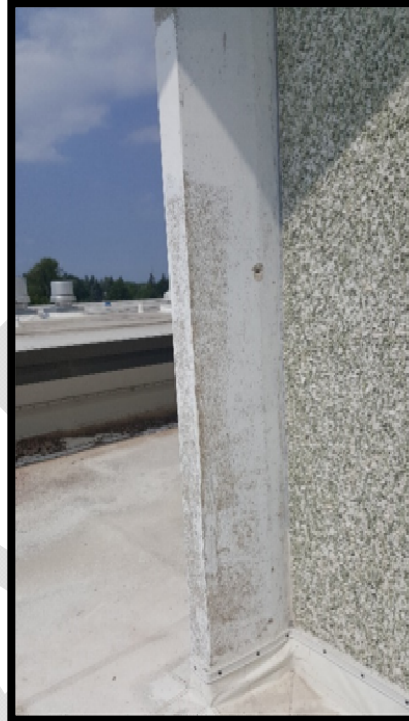
PLANETARIUM CUPOLA

The walls and columns in the cupola are in fairly good condition. Power wash and reseal and/or paint. Re-caulk where columns meet block and any penetrations. The columns with spalling shall be repaired by same methodology as columns at the ground level. Caulk where the columns meet the hard wall panels. As with the at grade level, this portion of the building needs to be power washed, any spalling

entire exterior surfaces need to be sealed as appropriate.

concrete repaired and joints between hard panels and columns and any penetrations need to be recalled. The and or painted

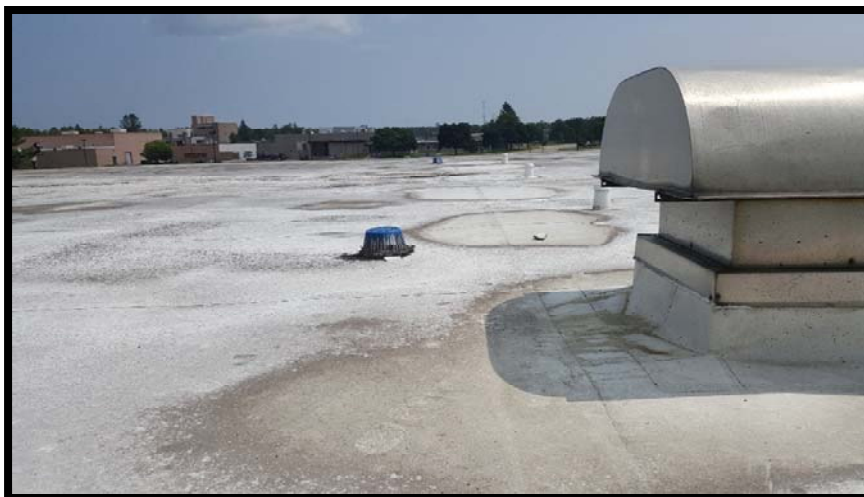
ROOF:

The roof is currently not experiencing any leaks but it has poor drainage in some areas resulting in ponding. Additionally, the roofing is approximately 20 years old and re-roofing should probably be considered at some time. It is recommended that when re-roofing all roofing and any insulation be removed to the deck. Then a tapered insulation system could be installed creating positive drainage to the roof drains. A thermoplastic TPO roofing

membrane, mechanically fasted (or fully adhered) is recommended (such as Duro-last.)

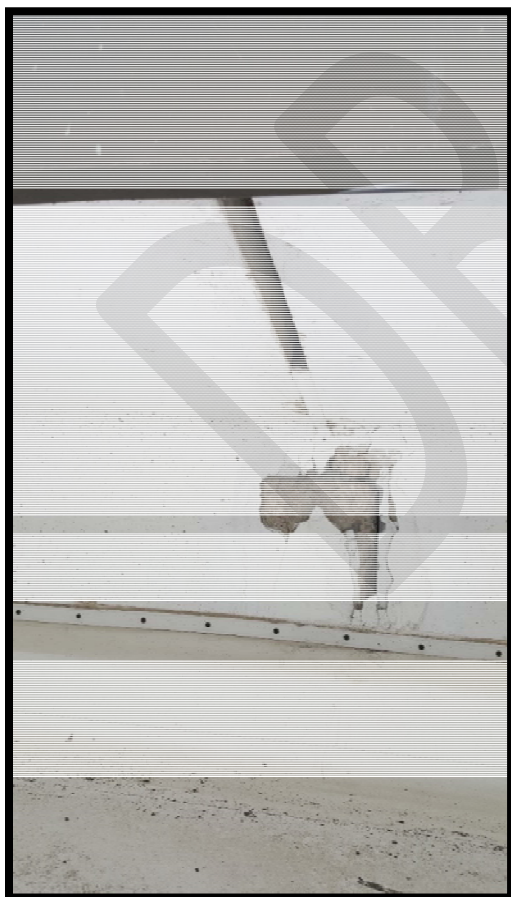
There is an expansion joint that needs to be repaired under the east wing overhang.

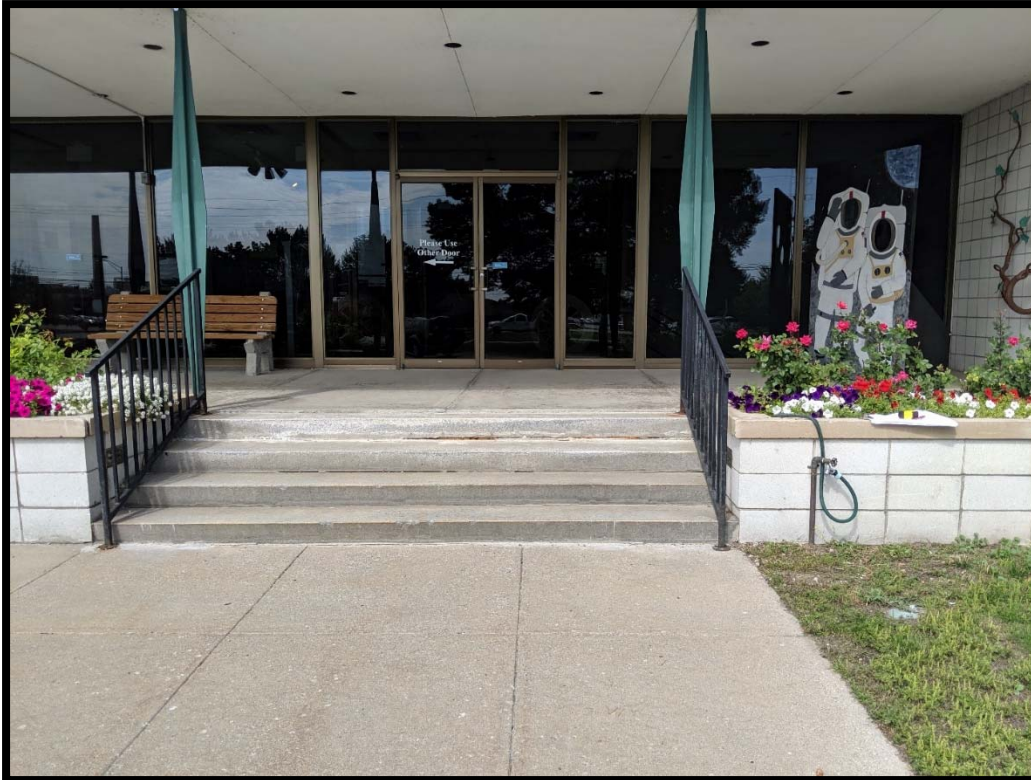
**MAIN ENTRY
STAIRS,
PORCH AND
PLANTERS ON
SOUTH
ELEVATION**

The hand rails are in poor condition and they should be removed and replaced with new railing and handrails meeting current barrier free rules. Code might require an additional railing at the center point of the stairs.

The concrete side walk in front of the entry is in poor conditions and should be replaced.

The front entry patio/deck, shall be power washed. Caulk removed from cracks and replaced with new. Caulking where deck meets walls shall be removed and replaced with new. The granite steps shall be removed, and reshaped and re-installed in new full mortar bed. Option would be to remove the steps and replace with new cast concrete steps.
