STUDY OF REPAIR AND RENOVATION OPTIONS

405 River Street
Alpena, MI 49707

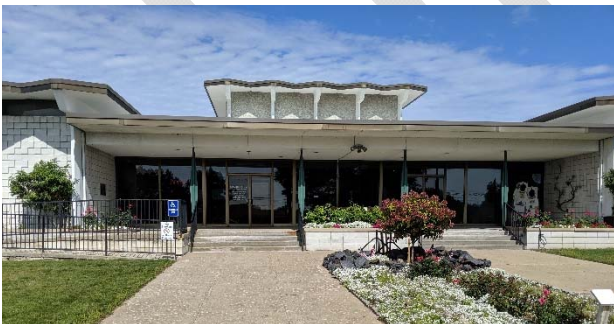
Many of the exterior columns are showing signs of deterioration marked by spalling and popping of the concrete, exposing re-rod. This needs to be corrected to prevent water from continuing to penetrate the column and rust out the re-rod which would eventually lead to failure.
